Alternative installation of the Window Cavity Closer

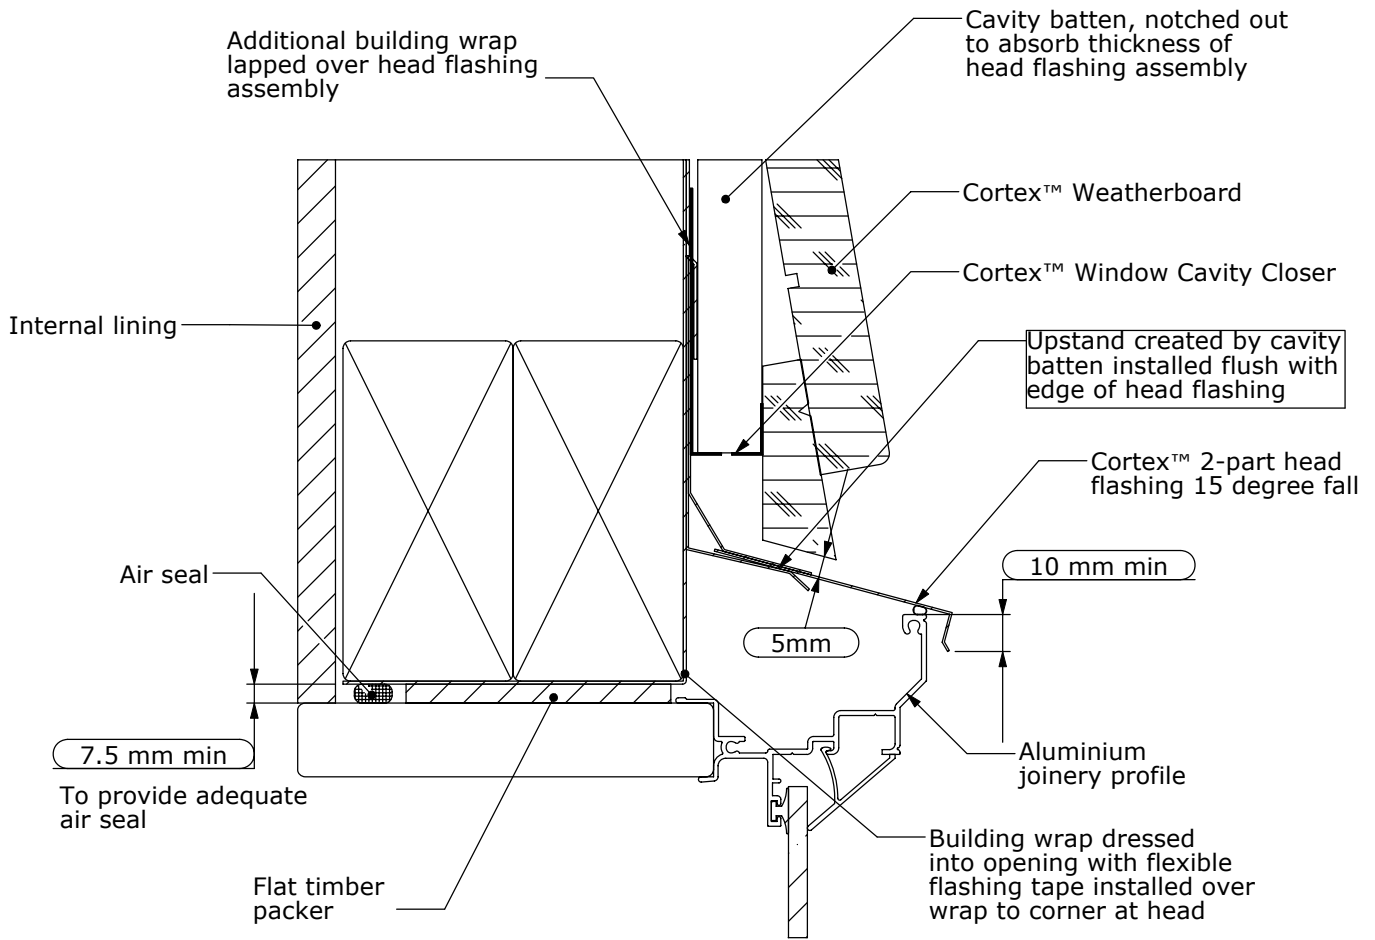
Depending on the location of the weatherboard in relation to the head flashing, a gap may be created. To effectively seal this gap, the cavity closer can be installed backwards. This method also eliminates the need of a cant strip.

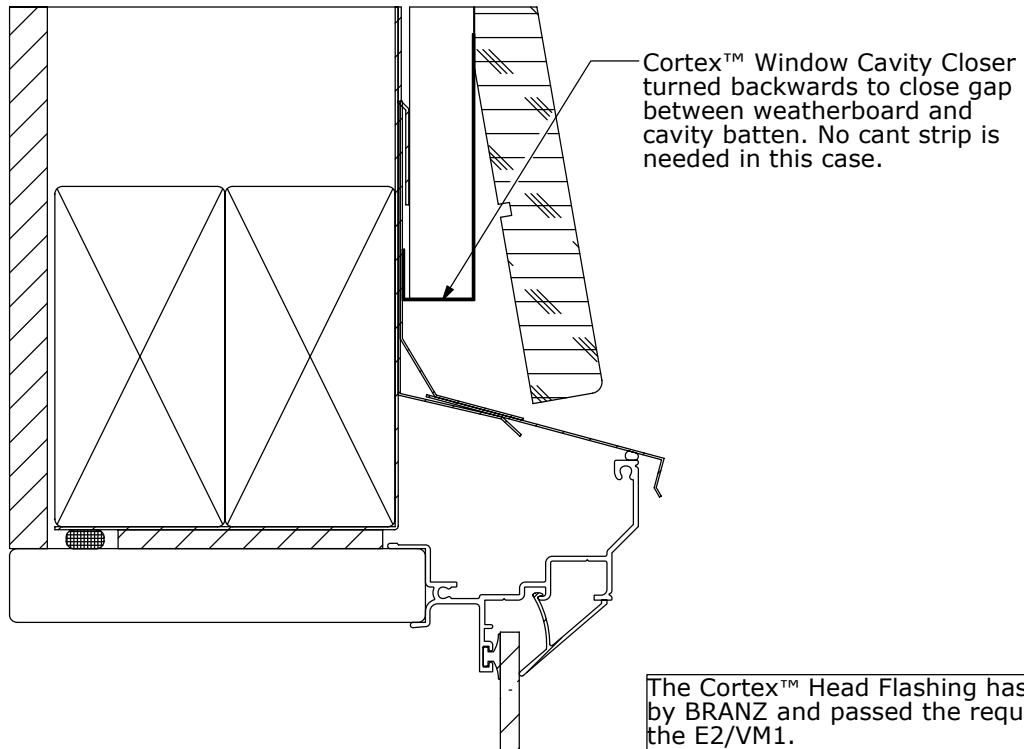
The Cortex™ Head Flashing has been tested by BRANZ and passed the requirements of the E2/VM1.
